WATER POLLUTION SURVEY

TOWN OF GANANOQUE

COUNTY OF LEEDS

1964

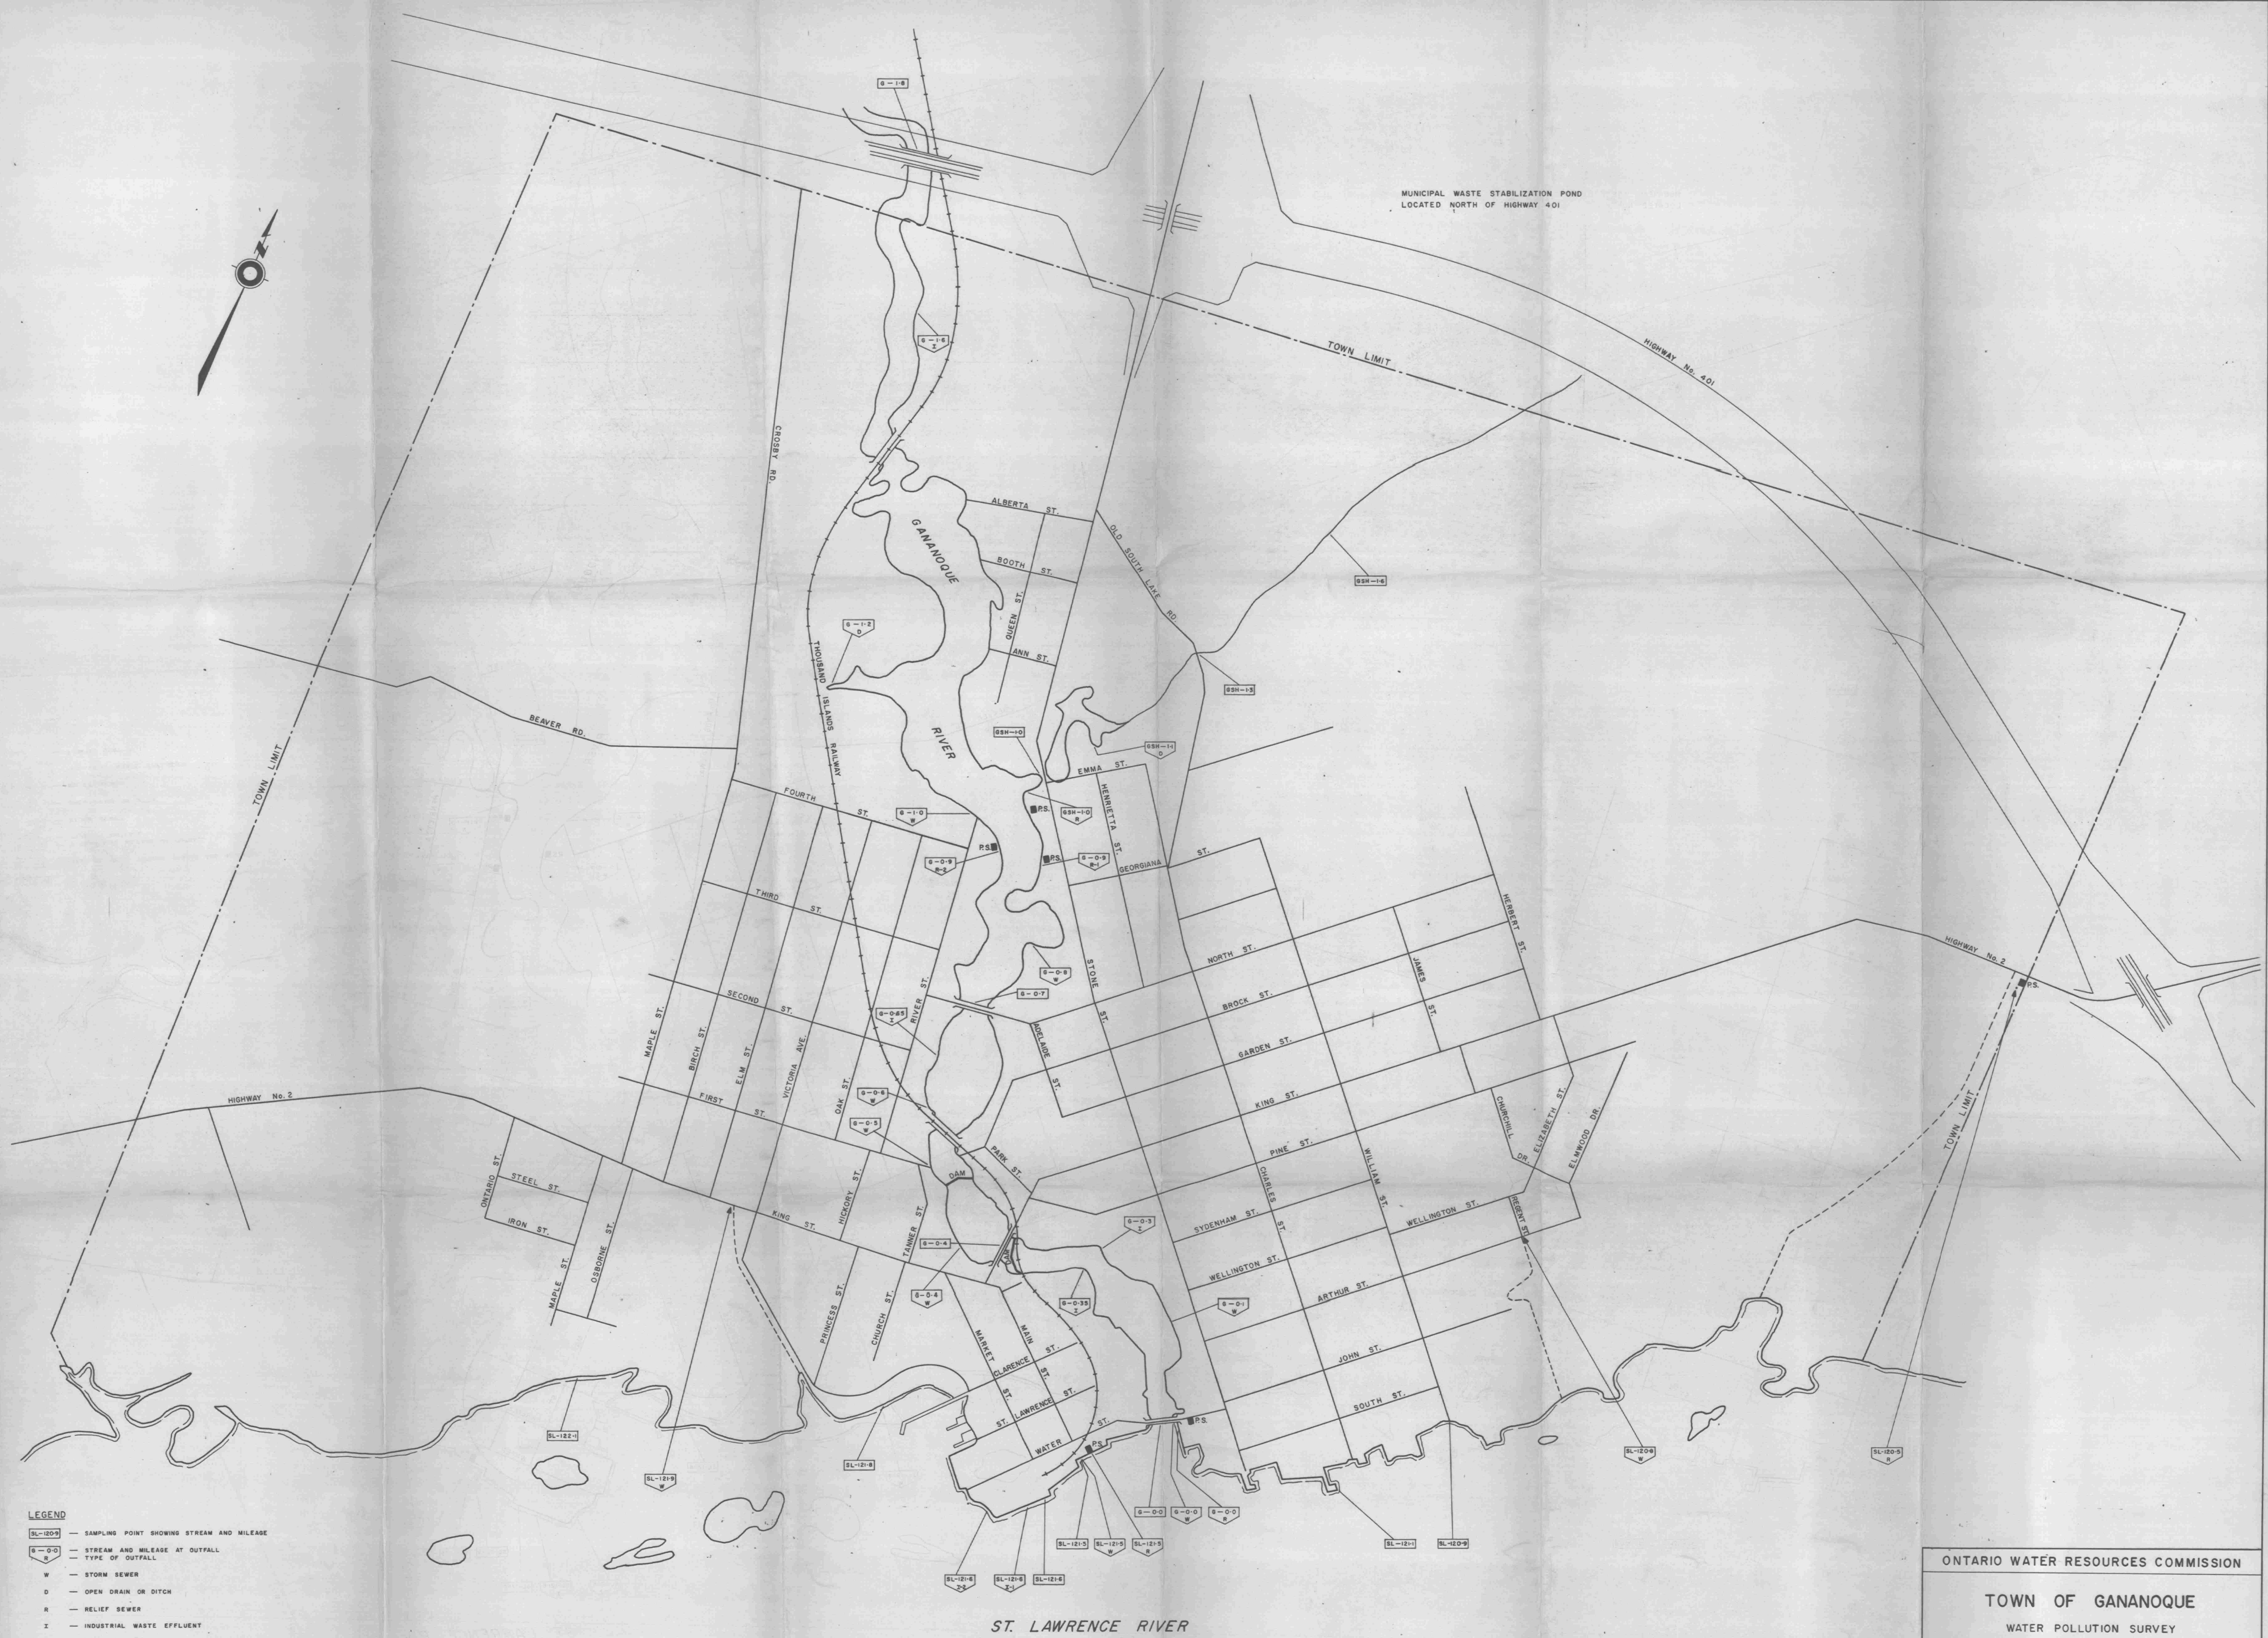
CHECKED BY: DRAWING No: 65-55

Samples were collected from the Gananoque River, the St. Lawrence River, and from evident discharges to the water-courses. Bacteriological examination and sanitary chemical analysis were performed at the Ontario Water Resources Commission Laboratory in Toronto. The sample results are listed in the appendices to this report. The sampling point locations are indicated on the appended map. Seasonal weather prevailed during the survey.
